# Marine Technologies, Inc.

## STORM DRAIN INSPECTION

**ANNAPOLIS HARBOR  
ANNAPOLIS, MARYLAND**

**JUNE 5, 2013**

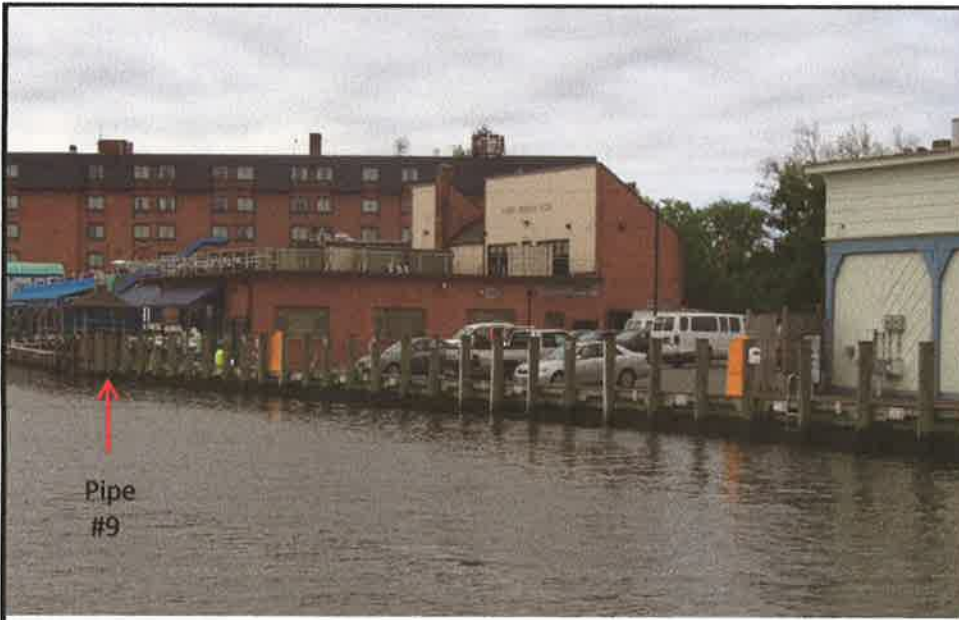
**PHOTO NO: 1**

North Wall

Pipe #9

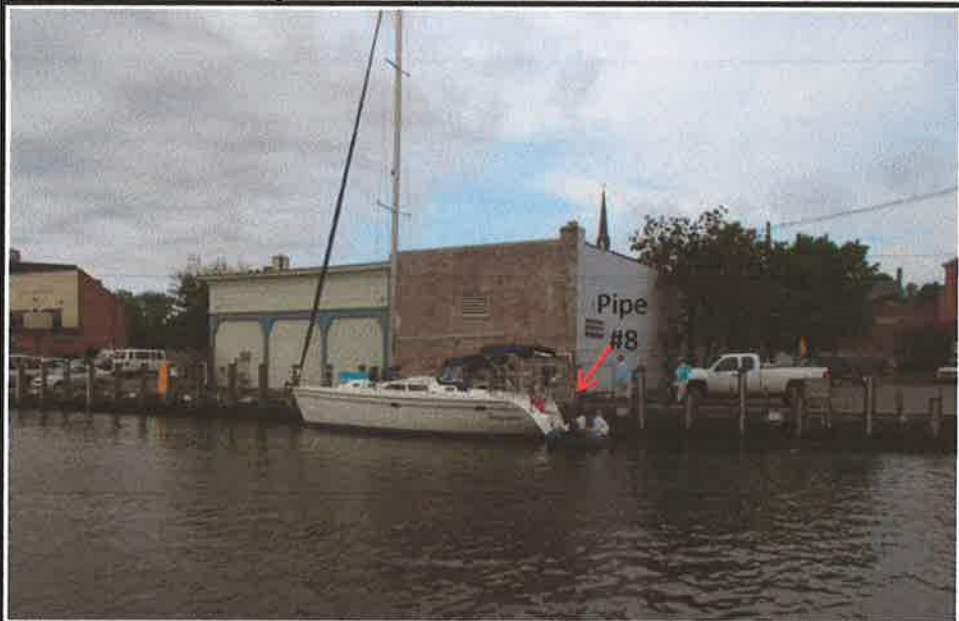
**PHOTO NO: 2**

North Wall

Pipe #8

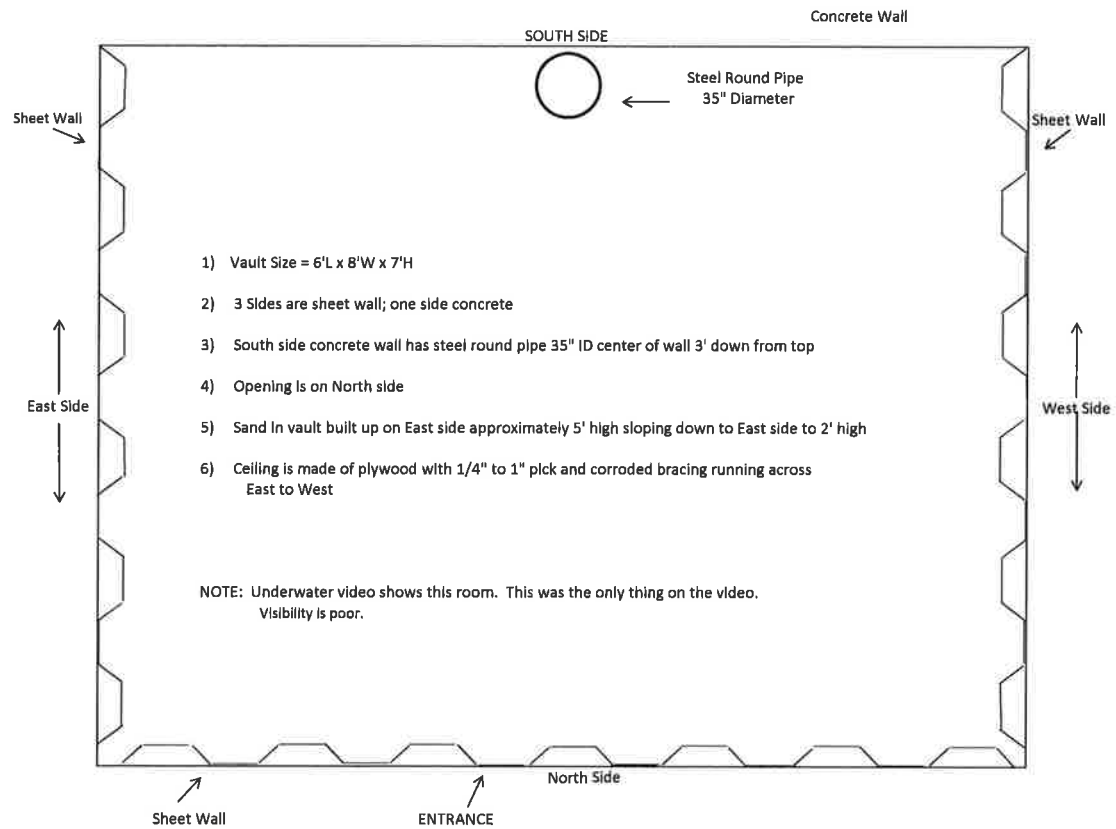
Vault by Storm Drain #4 - Looking Down

RATING	COMPONENT	REMARKS
4	Drain Pipe #4  Location	<p>1) In the southeast corner of Harbor next to location of drain pipe #4, diver found no pipe, but did find an opening to a vault. The opening is deteriorated concrete with rebar exposed. The vault is 6'L x 8'W x 7'H</p> <p>2) The vault has 4 sides: the north, west, and east sides are steel sheet wall. While the east and west sides are in good condition, the north side is deteriorated where the entrance to the vault is.</p> <p>3) The south side is a concrete wall in good condition. In the middle of the wall 3' down from the top is a 35" steel round pipe in good condition. There is sand in the vault approximately 5' high on east side and slopes to 2' high on the west side.</p> <p>4) Top of vault is made of plywood. When doing pick penetration diver found anywhere from 1/4" to 1" of pick penetration.</p> <p>5) Also appears some type of steel bracing runs along the plywood which is heavily corroded.</p>

At the Drain Pipe #4 location, diver found opening in sheet wall which led to a vault under

the walkway around the Harbor. No pipe was located and is believed to be buried in sand.

There are no repair recommendations at this time.
